Standard Operating Procedures: Survey Marker Installation and Monitoring

The Buzzards Bay NEP and the Buzzards Bay Coalition are collaborating on a long-term study of salt marsh loss, sea level rise, and habitat change around Buzzards Bay. Monitoring the selected sites will help improve our understanding of the causes of marsh loss around Buzzards Bay and help develop possible mitigation strategies. This summary provides an overview of the monitoring approach. Details that are more specific will be contained in an EPA-approved Quality Assurance Project Plan that will be provided to municipal conservation commissions prior to survey work and posted online. Protocols will be put in place to minimize impacts and disturbance to the marsh.

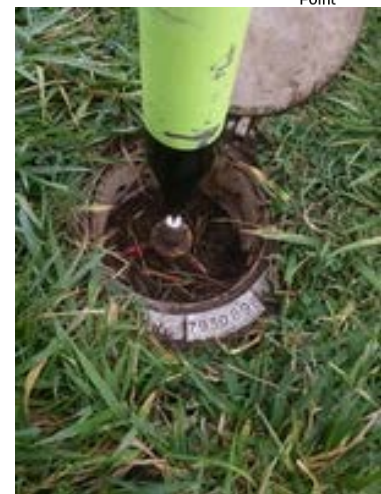
Fig. 1. Top: Schematic of the monument (from NGS (2010), *Benchmark Reset Procedures*). Middle: finished installation. Bottom: Optional disk marker for existing structure.

- 1) Install a NGS rod type survey benchmark in an adjacent upland area (Fig. 1, top and middle; disk marker optional),
- 2) depending on the site, install 4-10 PVC pipe markers (2 to 5 transects) within the marsh to establish permanent transect lines (1-inch PVC pipe driven with a hammer to within 4 inches of the marsh surface and capped),
- 3) monitor elevation, vegetation, and other features along these transects up to 3 times per year for the first two years, then once per year thereafter (some *Phragmites* or vegetation trimming may be required around the benchmark to allow line of sight),
- 4) conduct a crab population survey with pitfall traps,
- 5) install a temporary staff with sensors in a tidal creek to document tidal elevation, and
- 6) periodically document the elevation of the High Tide Line during different tidal and weather conditions.

Elevation benchmark monuments will be installed in uplands adjacent to selected marshes within 500 feet of monitoring work. The survey markers will be NGS 3-D deep driven rod markers made of 9/16" stainless steel (Fig. 1), driven to refusal. The steel rod is driven with a gas-powered hammer as shown in Fig. 2. The top 2.5 feet of the steel rod is surrounded by a 1-inch PVC pipe containing food-grade non-toxic grease. This design prevents movement of the ground due to frost heaves from affecting the elevation of the marker, and this benchmark type meets the highest government standards for benchmark elevation stability. The housing for elevation markers must be installed at ground level and any excavated materials must be removed from the immediate site.

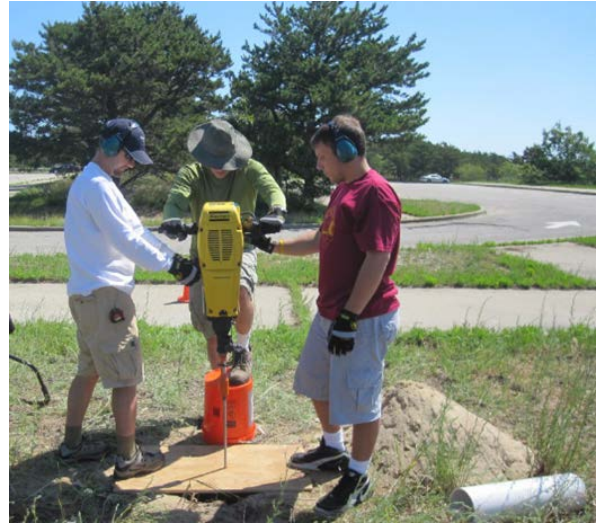
Fig. 2. Using a gas powered jackhammer to drive the steel rods into the ground (from a URI guide for installing elevation monuments on National Park Lands).
